# MARK-3®

### 12-4AS ALUMINUM DRIVE BUSHING

#### **Overview:**

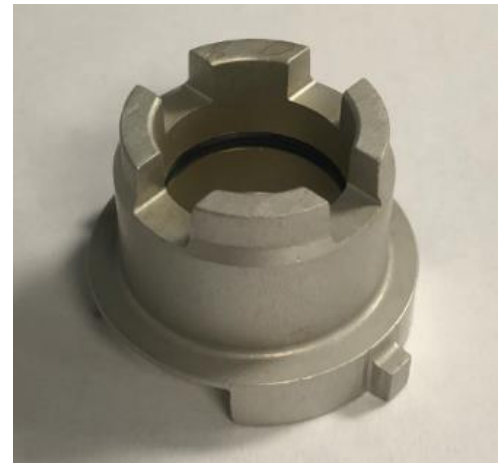
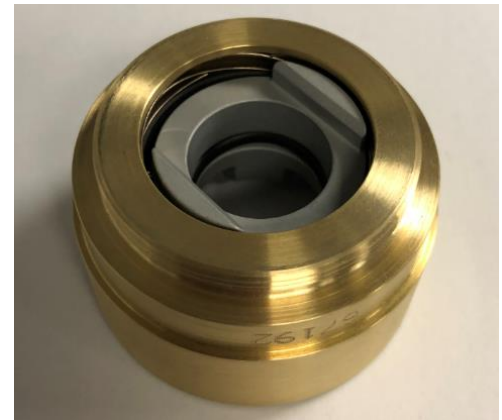
The 12-4AS drive bushing has been integrated into the 12-28NS Mechanical Rotary Seal (700008) and is no longer required. If the drive bushing and/or old 12-28N mechanical rotary seal are damaged, we recommend replacing both parts by the 12-28NS Mechanical Rotary Seal.

The 12-28NS Mechanical Rotary Seal (700008) was introduced back in 2010. Several improvements were made to the design of the rotary seal. The external pressurized seal design features a proprietary material which incorporates a blister-resistant carbon seal face and a silicon carbide seat. As a result, we observe lower weeping rates, increased durability under partial dry running and improved overall reliability. The integration of the drive bushing increases the robustness of the seal and removes a component out of the pump assembly.
